BELOW-GRADE WATERPROOFING FAILURES

— Case Study

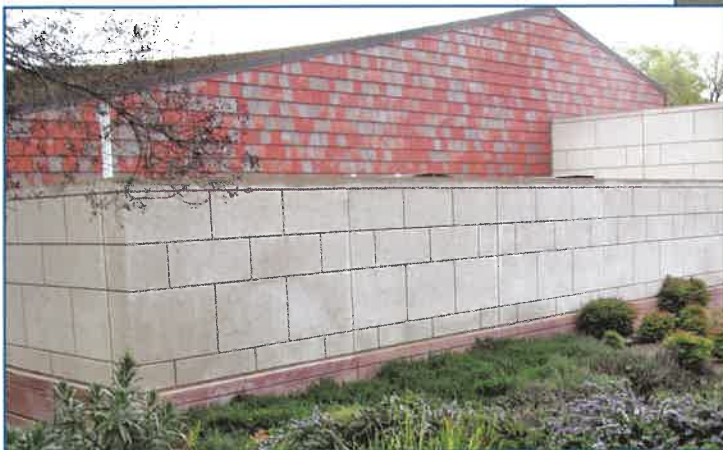
Figure 1 – Boiler room has perimeter cast-in-place concrete walls (commencing below the reddish precast panels) extending down to the concrete footings. (Whitish precast concrete panels extend up from the red panels.)

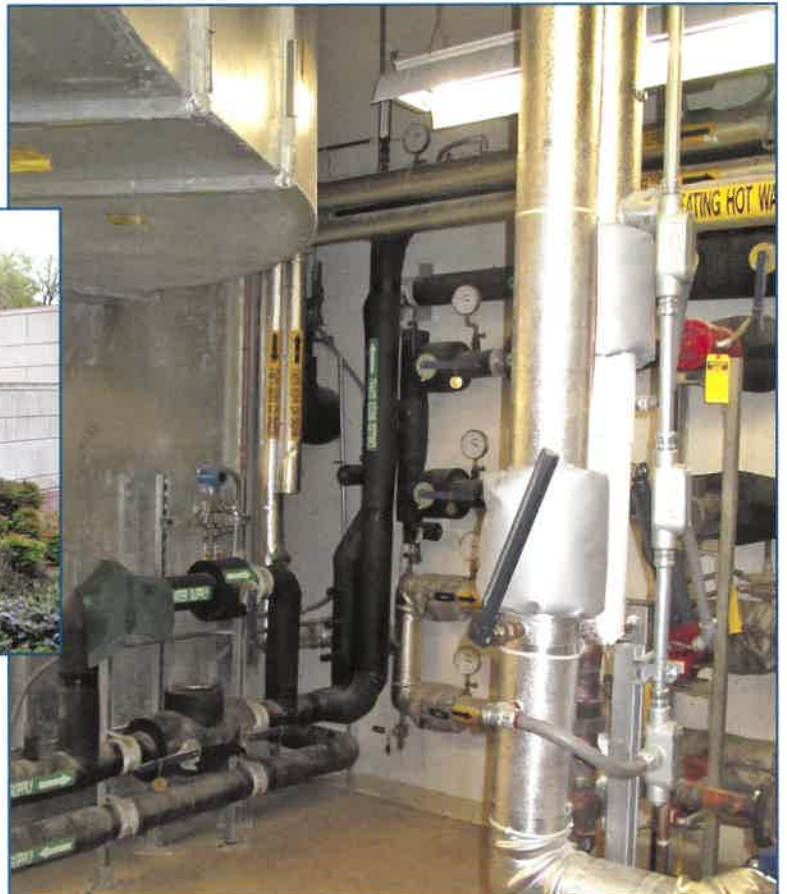
Figure 2 – A cast-in-place concrete wall encloses a 70-ft.-long boiler room that serves the entire campus.

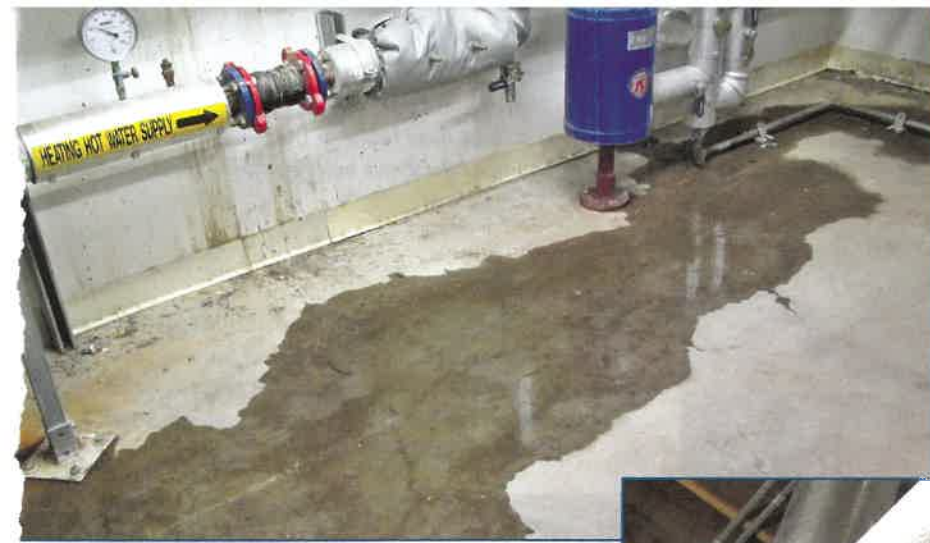
Figure 3 – Even during dry weather, groundwater infiltrated the boiler room at floor-to-wall transitions. The water stains at the lower cast-in-place wall (at left) resulted from leakage occurring at the top of the concrete wall (see Figure 4).

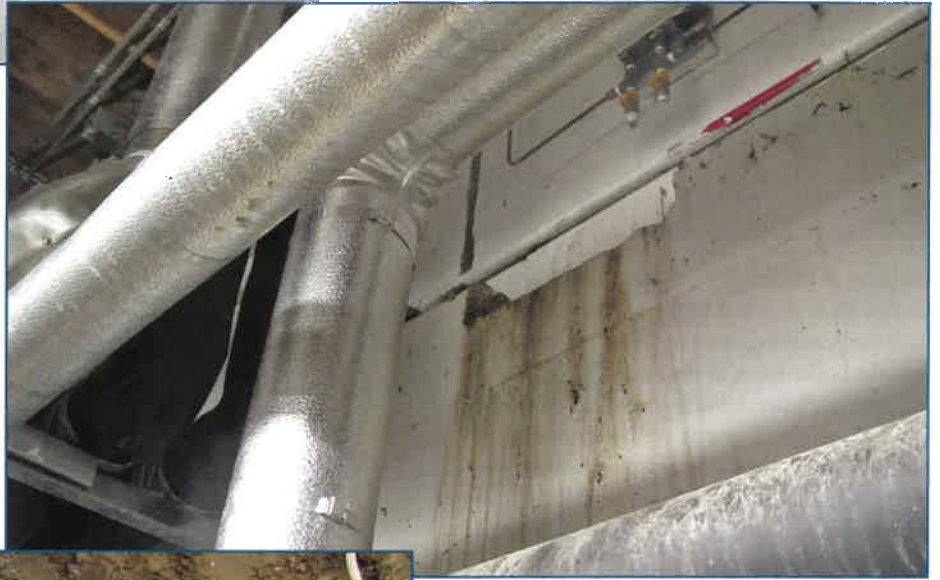
capabilities by swelling to nearly 15 times its dry volume when it absorbs water. In hydrated state, under sufficient hydrostatic pressure, bentonite becomes a water-repelling gel that will adhere to many different materials—concrete, stone, wood.²³

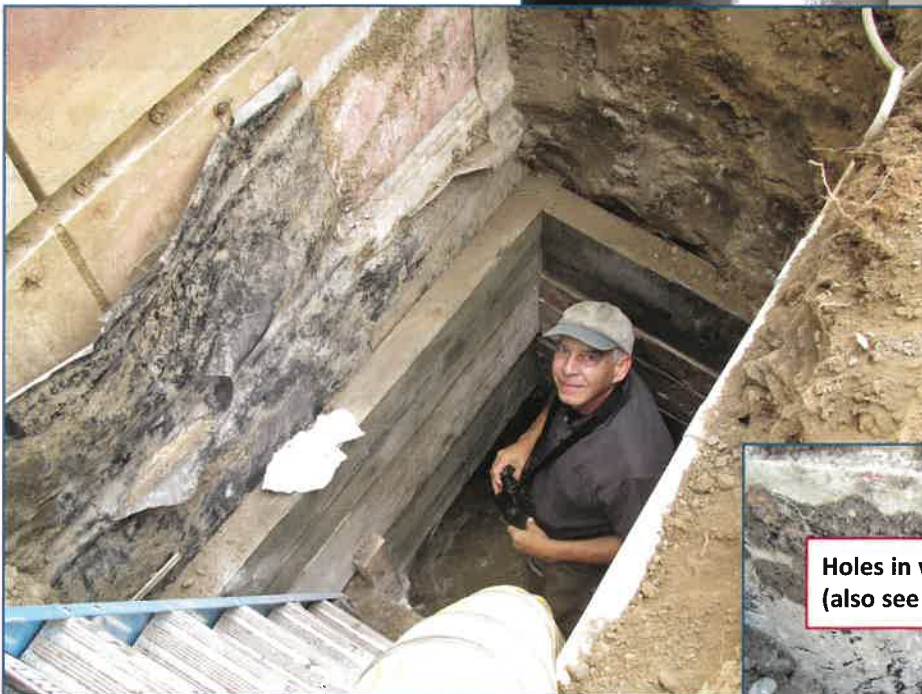
Figure 5 – Upon commencing the excavation process, a raggedy, poorly attached, and extensively torn sheet waterproofing membrane was exposed. (The missing section at the top of this photo was extracted by our crew for sampling purposes.)

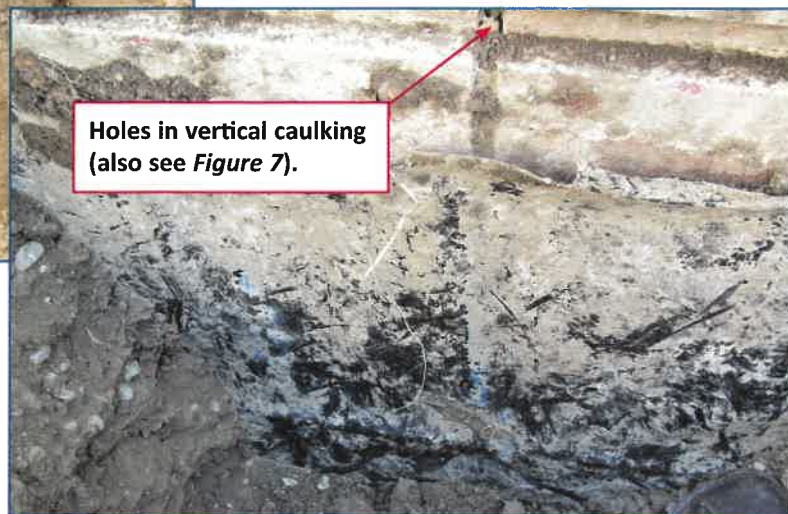
Figure 6 – The sheet waterproofing had been “shot-pinned” to the reddish precast panels without a termination bar that would have served to prevent the membrane from tearing loose during later backfilling. (Note at the top of this photograph the holes in the vertical caulking separating two of these panels; also see Figure 7 and Figure 8.)

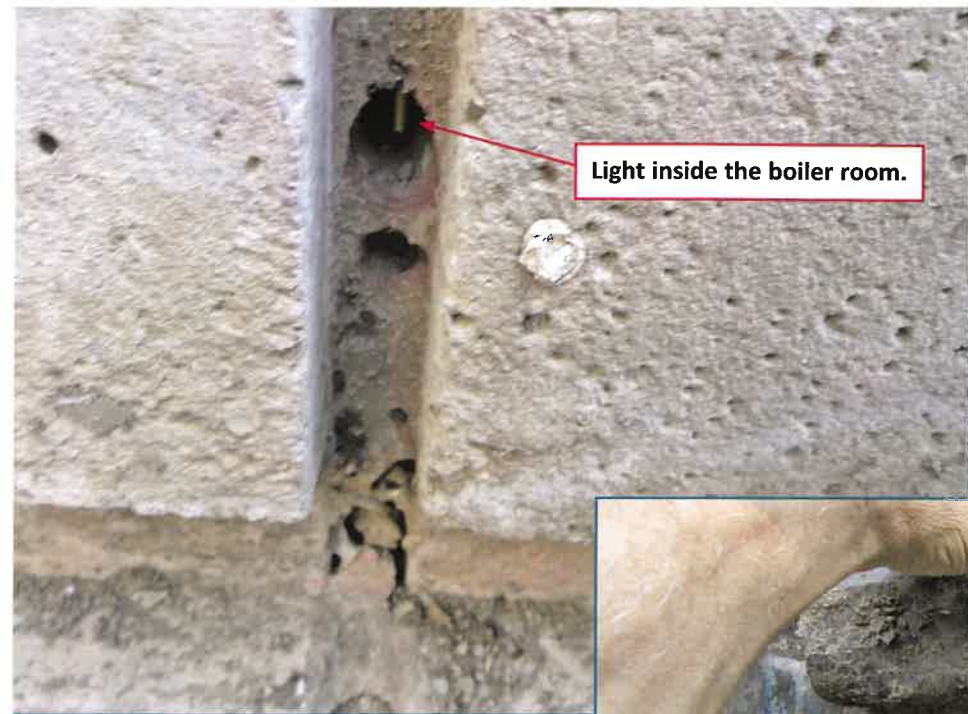
Figure 7 – (Same caulk joint seen in Figure 6.) The defense argued that these below-grade holes were caused by snails. At the upper hole, light from inside the boiler room can be seen.

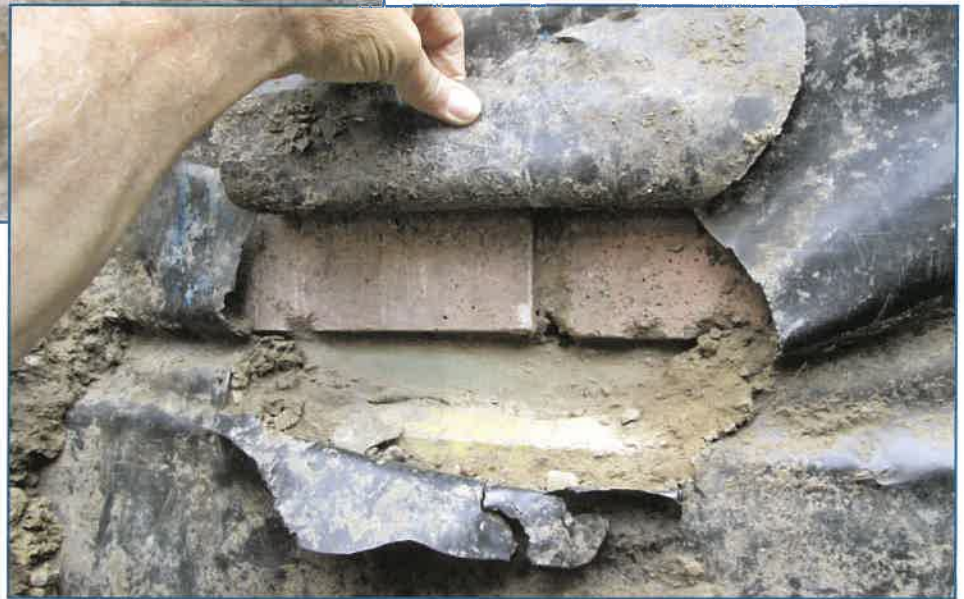
caulking at the reddish precast panels, as seen in Figures 6–8. A test probe inserted into the damaged caulking seen in Figure 8 extended into the boiler room at the area of water staining seen in Figure 4. Further, per the exemplar “clump” seen in Figure 9, we noted that large portions of the bentonite clay had washed out of the system. Finally, as evidenced by Figure 10, we observed that the horizontal caulk joint separating these two wall systems was not bonded to the precast panels, providing yet another route for water infiltration into the boiler room.

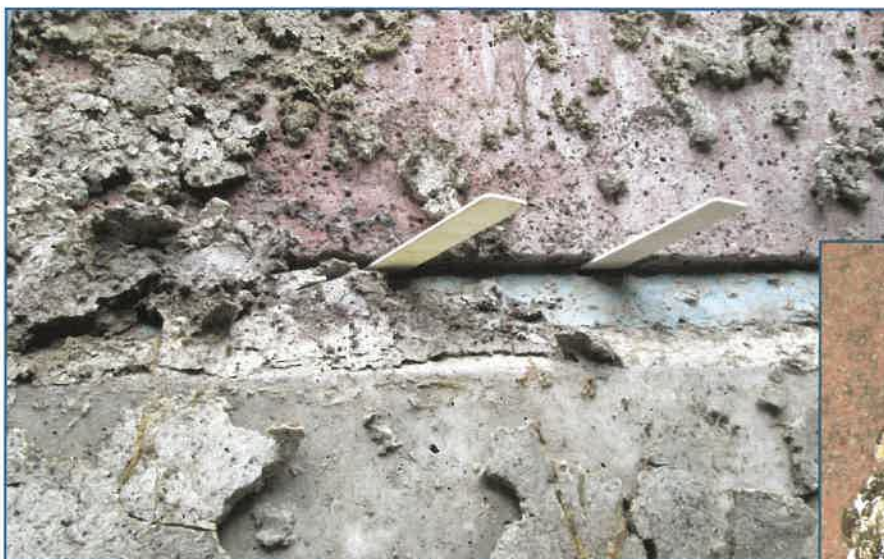
Figure 10 – The caulk joint between the two wall systems was not watertight due to failed bonding at the precast panels.

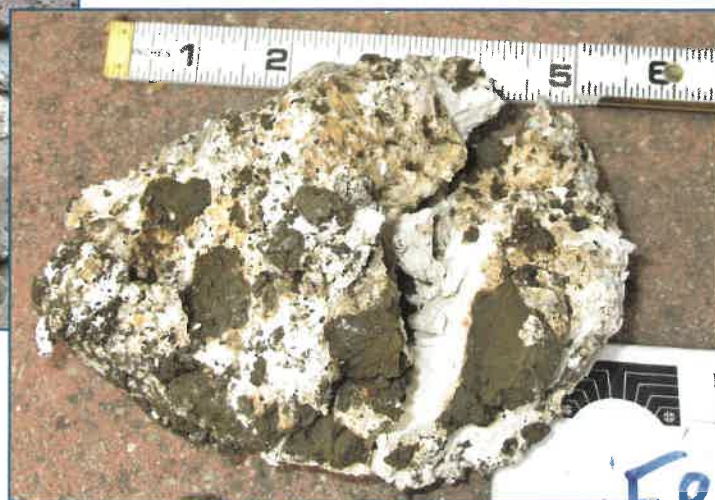
Figure 9 – During excavation, we found this clump of bentonite clay directly below the ripped membrane seen in Figure 8.

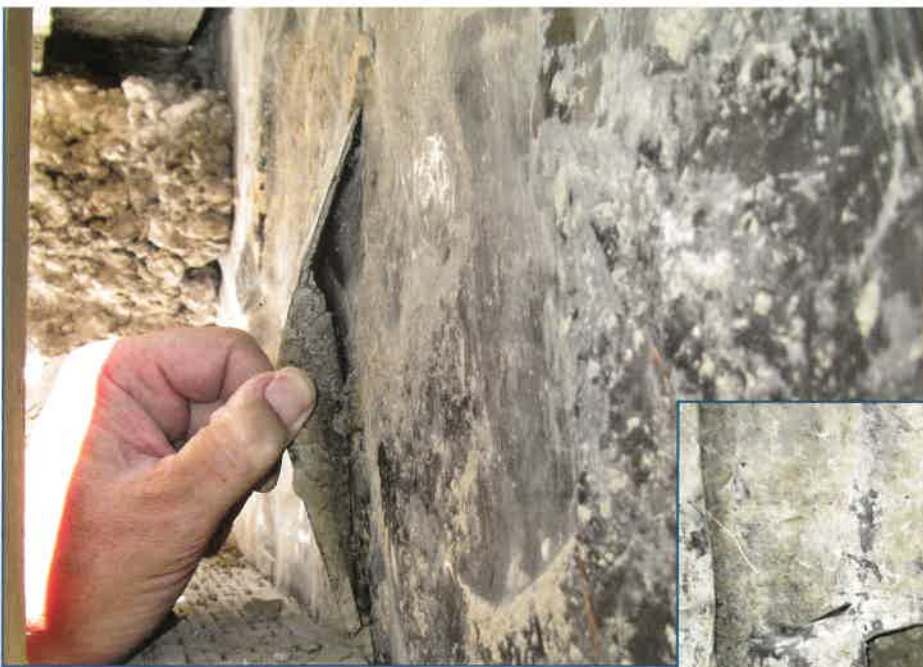
Figure 11 – Multiple breaches in the membrane due to damage during backfilling were observed at all levels of the excavation.

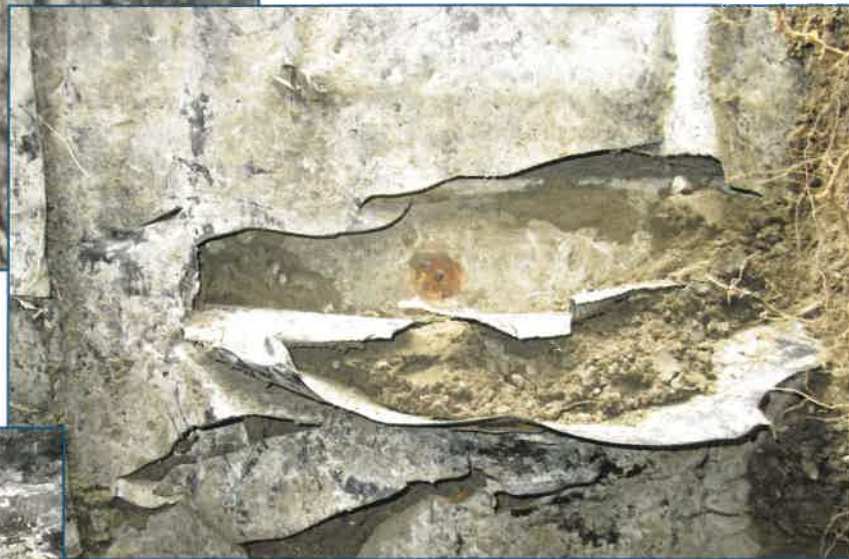
Figure 13 – (below) Near the bottom of the excavated trench, breaches in the waterproofing still remained prevalent.
