‘Wheel Stop’ Tripping Hazards in Pedestrian Paths of Travel

- **Lonnie Haughton, GC, MCP, CASp – Principal Codes Consultant**
- **David M. Field, AIA, NCARB, CASp – Principal Architect**

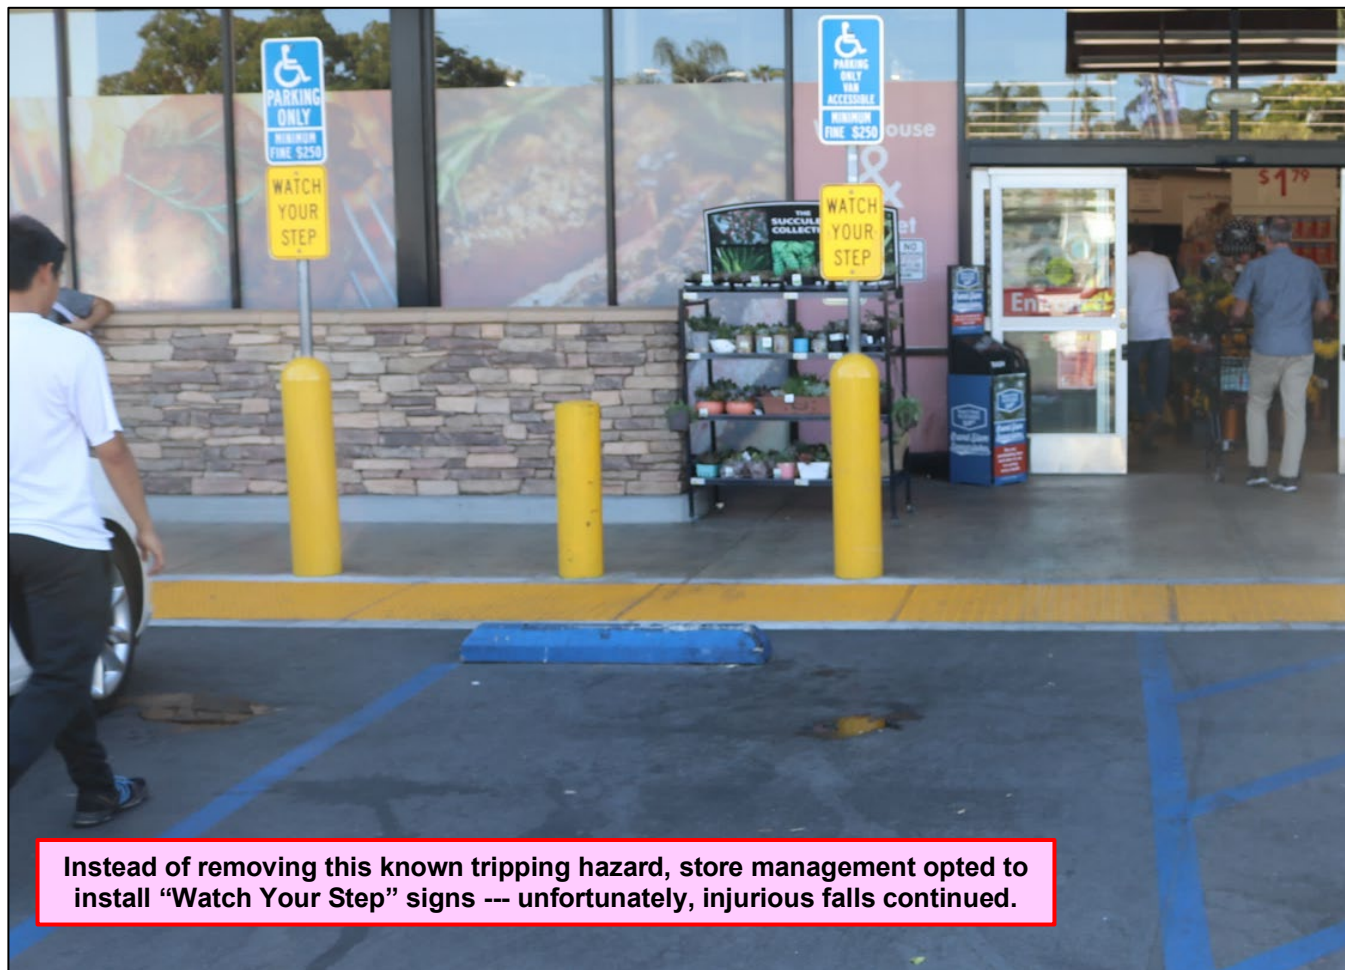
Photo 2 – At this grocery store in Southern California, a primary route of pedestrian travel from the parking lot toward the entry doors led across this wheel stop --- *what could go wrong?*

- In the above Photos, such vehicle deterrence instead is achieved by the structural bollards.³
- We pedestrians tend to take the shortest route from Point A to Point B when walking across parking lots and through parking garages.⁴

- The greater the rate of pedestrian traffic across any particular wheel stop or comparable hazard, the greater the likelihood of pedestrian trip-and-fall incidents occurring over time --- as such, injurious falls are virtually inevitable at the heavily trafficked paths of travel seen in these Photos.

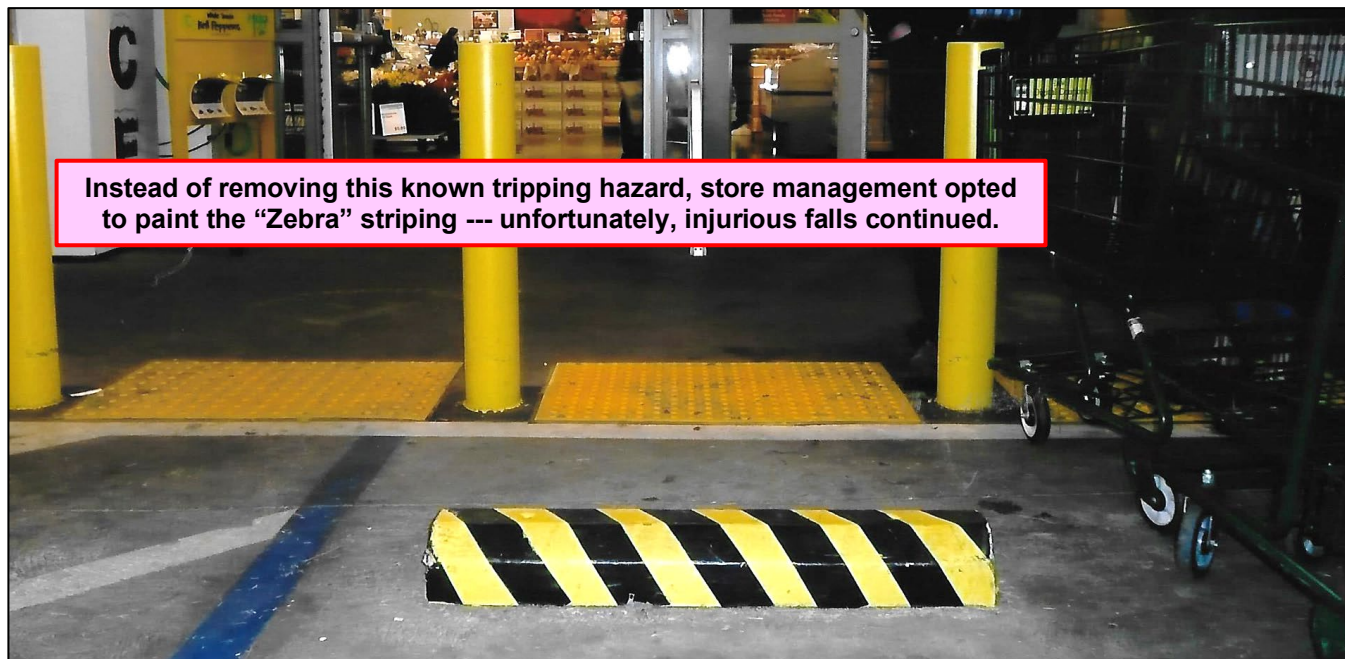
Photo 3 – The most direct route for customers exiting this Northern California store into the adjacent parking garage led across this wheel stop --- *what could go wrong?*

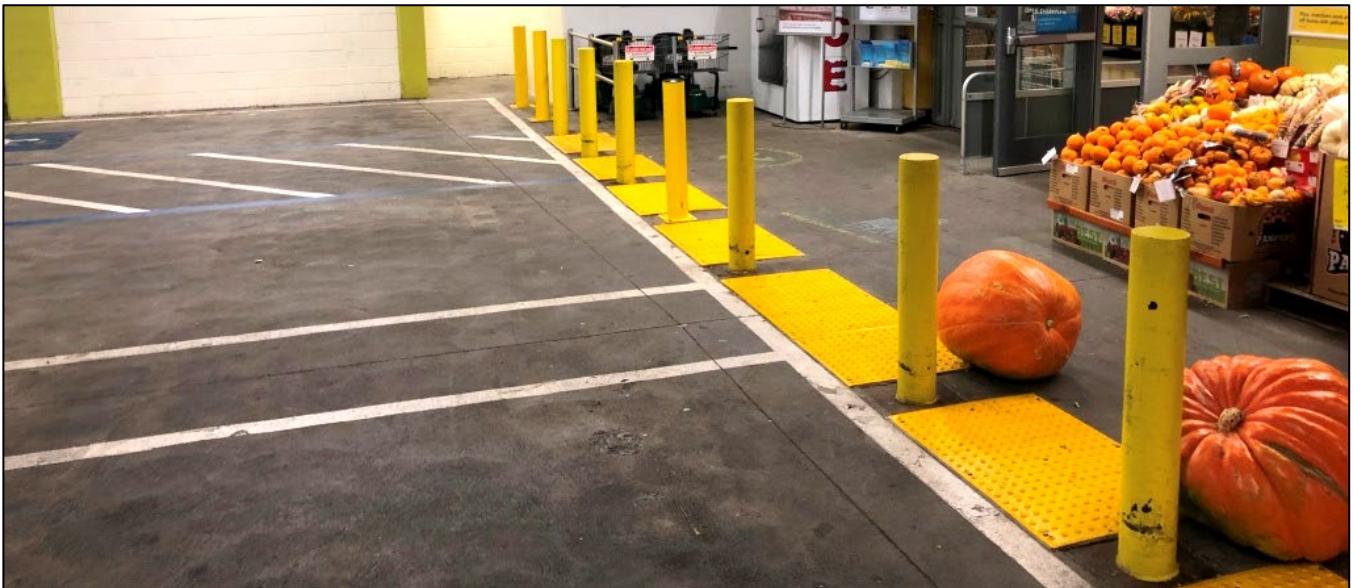
Photo 4 – The structural bollards at this Northern California store eliminated any need for wheel stops.

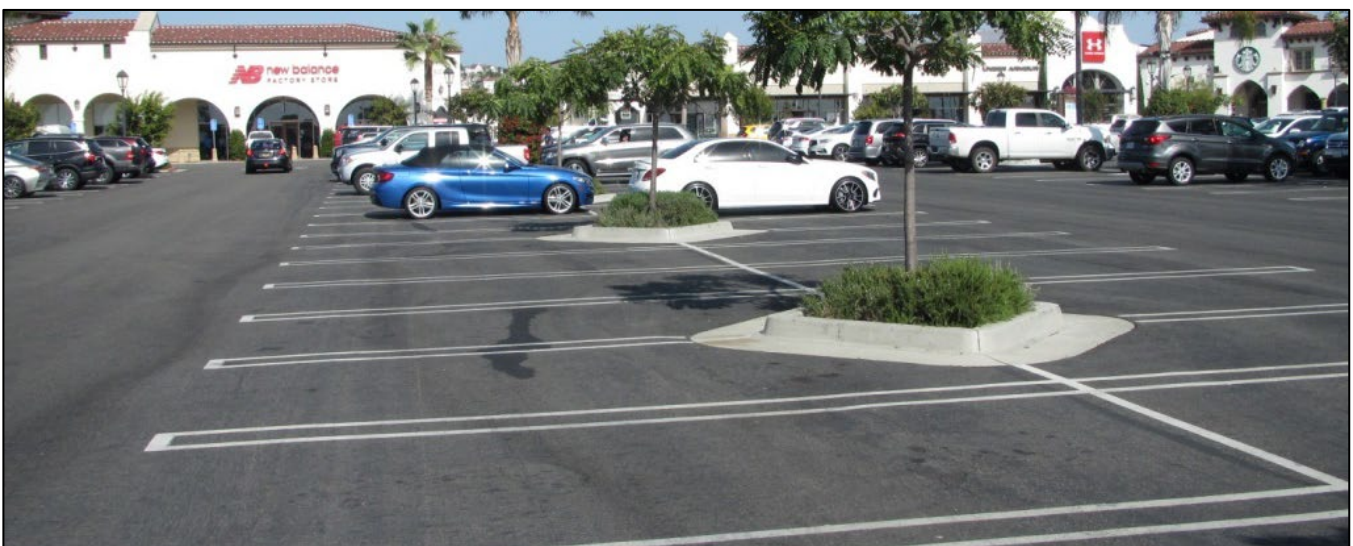
Photo 5 – Designers of this Southern California parking lot similarly elected to eliminate wheel stop tripping hazards.
